**Flood Control Project Maintenance
Levee Inspections**
LMA District Cover Sheet
Spring 2016 Levee Inspection Results

American River Flood Control District

Spring 2016 Levee Inspection Results

Waterway			Bank	Unit Miles
Unit No. 01 Arcade Creek			Left	2.08
	Spring (March - May)	Summer (June - August)	(September - November) Fall	Winter (December - February)
Unit Maintenance Rating (Fall Only)				
Date of Inspection	3/2/2016 - 3/2/2016			
DWR Inspector	Maksim Khashchuk			
Accompanied By	Richard Marck ARFCD			
	Sterling York

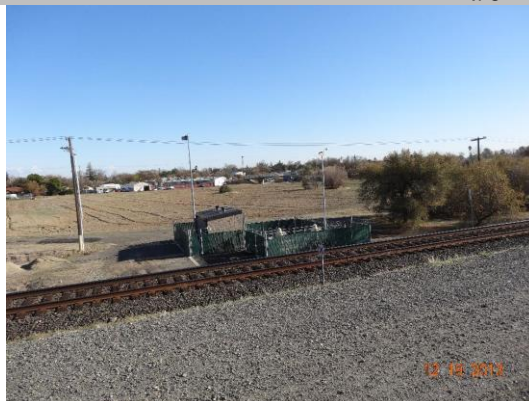
Photo 1 of 2 : UCIP_SP_2016_28585_52634.jpg

Comment Code					
Inspector Comment					
FS_ID:28585 DS_ID:24273 EP_NO: N/A Repair Type: Non-Urgent Crossing Status: Indicator Found UCIP Comments: Multiple pumps visible on landward side however unable to confirm additional crossing only 1 crossing was confirmed at this location. Need to contact owner to determine status of crossing. FIELD_STRUCT_DESC: 24-inch pipe sleeved through 30-inch CM pipe through the levee, 2.8 feet below the crown. Annular gap grouted. Flap gate on waterside (WS) end. Slide gate in concrete pipe riser at WS toe. Pump on structure over concrete sump on landside (LS). (USACE-1959). This entry matches the Drainage or Irrigation Structure referenced in O&M manual (Station 216+00). FS Date: 12/19/2013

Overview of landward side.

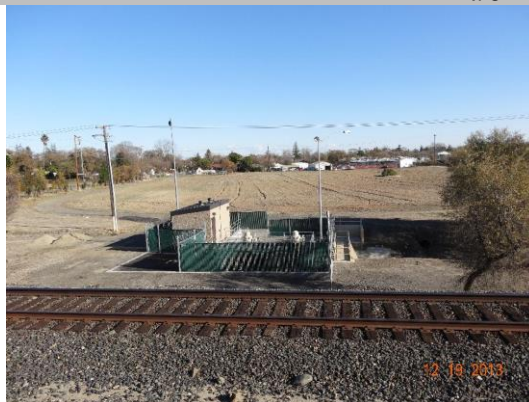
Photo 2 of 2 : UCIP_SP_2016_28585_52635.jpg

Overview of pumps located on landward side.

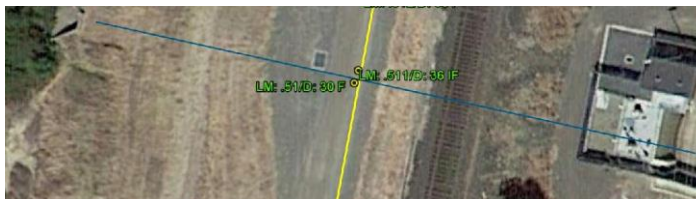
Photo 1 of 2 : UCIP_SP_2016_29763_55045.jpg

Comment Code					
Inspector Comment					
FS_ID:29763 DS_ID:24274 EP_NO: 6064 Repair Type: Non-Urgent Crossing Status: Found UCIP Comments: Need to determine the status of crossing. Unable to confirm if crossing found in field corresponds to this entry. FIELD_STRUCT_DESC: [Pump Station No. 153] 36-inch steel drainpipe through the levee, 5.2 feet below the crown. Corrugated metal (CM) cutoff wall around pipe between center and waterside (WS) shoulder. Siphon breaker in concrete box on WS slope. Second siphon breaker in concrete box on the landside (LS). Portion of pipe exposed on WS slope. Concrete "U" headwall and flap gate on the WS end. Rock revetment on WS slope. (Permit No. 6064-1968) FS Date: 12/19/2013

Approximate alignment provided by City of Sacramento indicates a 36-inch storm drain at this location.

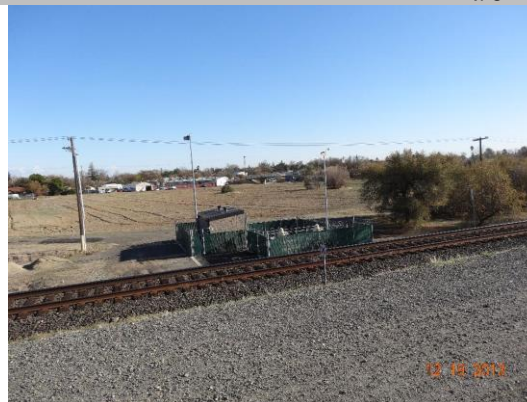
Photo 2 of 2 : UCIP_SP_2016_29763_55042.jpg

View of landward side--pump station with multiple pumps.

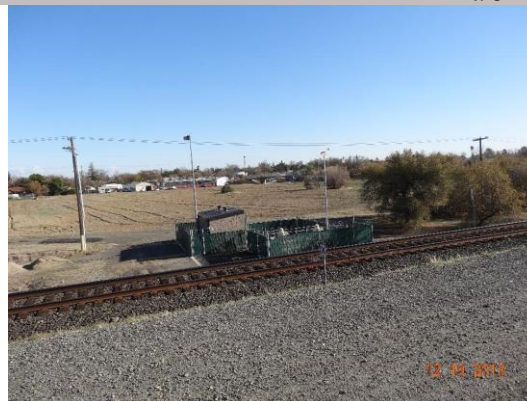
Photo 1 of 2 : UCIP_SP_2016_28584_52631.jpg

Comment Code					
Inspector Comment					
FS_ID:28584 DS_ID:24612 EP_NO: N/A Repair Type: Non-Urgent Crossing Status: Indicator Found UCIP Comments: Multiple pumps visible on landward side however unable to confirm additional crossings. Only 1 crossing was found at this location. FIELD_STRUCT_DESC: 30-inch steel pipe sleeved through 36-inch CM pipe through the levee, 5.2 feet below the crown. Annular gap grouted. Siphon breaker in concrete box on the waterside (WS) slope. Pump on structure over concrete box on the landside (LS). Concrete U" headwall and flap gate on the WS end C.M. cutoff wall. Pipe sleeved through under Permit No. 6064 (1968). FS Date: 12/19/2013

Overview of landward side.

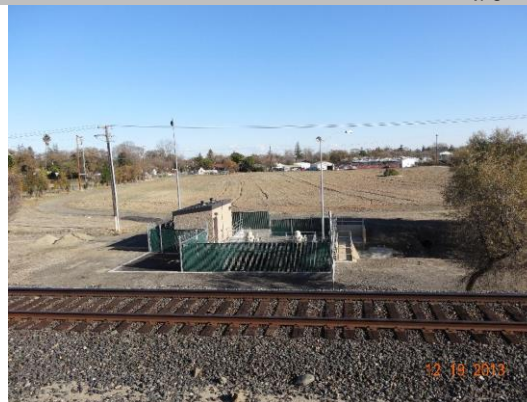
Photo 2 of 2 : UCIP_SP_2016_28584_52632.jpg

Multiple pumps located on landward side.

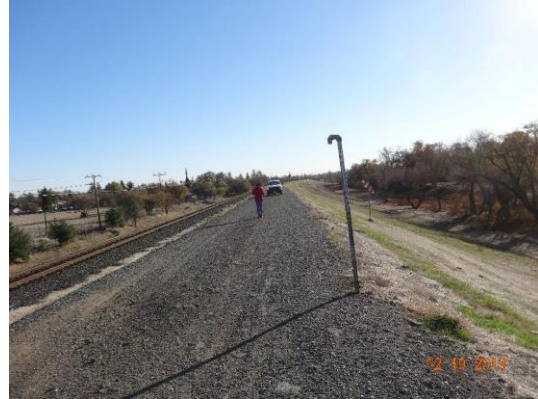
Photo 1 of 2 : UCIP_SP_2016_42130_52766.jpg

FS_ID:42130
DS_ID:24277
EP_NO: 2333
Repair Type: Non-Urgent
Crossing Status: Indicator Found
UCIP Comments: 11/3/2014 (DWR-Olivia) Need to contact owner to determine status of crossing. Priority under Part IX has been changed from Urgent to Non-Urgent as a measure to normalize the data. Markers present however unable to confirm pipe size. Recommend LMA to contact owner to determine additional information details--confirm pipe size, alignment, and last inspection completed confirming integrity of crossing. Need to contact owner to determine status of crossing. Unable to confirm if indicators visible on levee crown and landward side correspond to this crossing.
FIELD_STRUCT_DESC: 12-inch gas line through the levee, 3.0 feet below the crown. For emergencies contact PG&E at 1-800-811-4111. (Permit No. 2333-1957)
FS Date: 12/19/2013

Overview of levee crown at crossings.

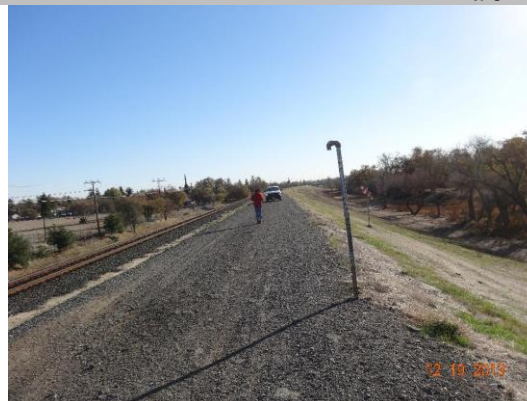
Photo 1 of 2 : UCIP_SP_2016_28666_52778.jpg

LM Start	1.03	Rating **	M	Issue No.	153
LM End	1.03	Issue Type +	En	Location *	WS
Category	Supplemental			GPS Latitude/Longitude	
				Start	End
Item	DWR UCIP Field Study			38.615772 °	38.615772 °
				-121.466971 °	-121.466971 °
DWR ID					
Comment Code					
Inspector Comment					
FS_ID:28666 DS_ID:24614 EP_NO: 1949 Repair Type: Non-Urgent Crossing Status: Indicator Found UCIP Comments: Need to contact owner to determine if pipe was left inside levee as part of abandonment process. FIELD_STRUCT_DESC: *Abandoned* 12-inch steel gas line through the levee, 3.0 feet below the crown. Pipe grout filled. Concrete cutoff wall around pipe under center of levee. (Permit No. 1450-1949) This entry matches the Drainage or Irrigation Structure referenced in O&M manual (Station 243+31). Pipe abandoned under Permit No. 17468 (2004). FS Date: 12/19/2013

Overview of levee crown at crossings.

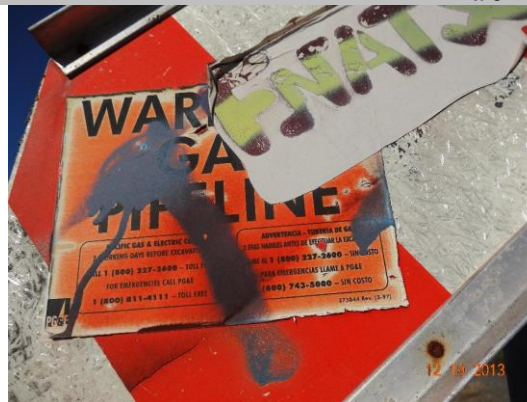
Photo 2 of 2 : UCIP_SP_2016_28666_52780.jpg

Marker with emergency contact information located on waterward slope.

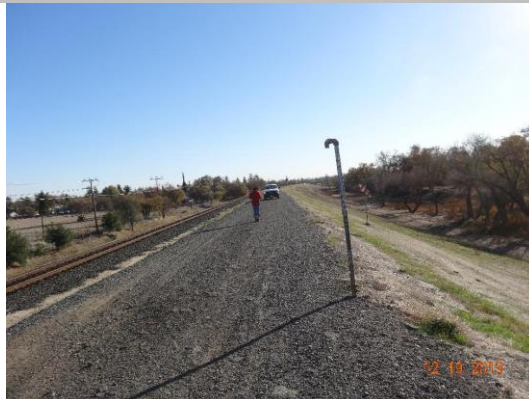
Photo 1 of 2 : UCIP_SP_2016_42131_52772.jpg

FS_ID:42131
DS_ID:24280
EP_NO: 17468
Repair Type: Non-Urgent
Crossing Status: Indicator Found
UCIP Comments: 11/3/2014 (DWR-Olivia) Need to contact owner to determine status of crossing. Priority under Part IX has been changed from Urgent to Non-Urgent as a measure to normalize the data. Markers present however unable to confirm pipe size. Recommend LMA to contact owner to determine additional information details--confirm pipe size, alignment, and last inspection completed confirming integrity of crossing. Need to contact owner to determine status of crossing. Unable to confirm if indicators visible on levee crown and landward side correspond to this crossing.
FIELD_STRUCT_DESC: 20-inch steel gas pipe through the levee, approximately 86.0 feet below the crown. For emergencies contact PG&E at 1-800-811-4111. (Permit No. 17468-2004)
FS Date: 12/19/2013

Overview of levee crown looking downstream at signs of crossings.

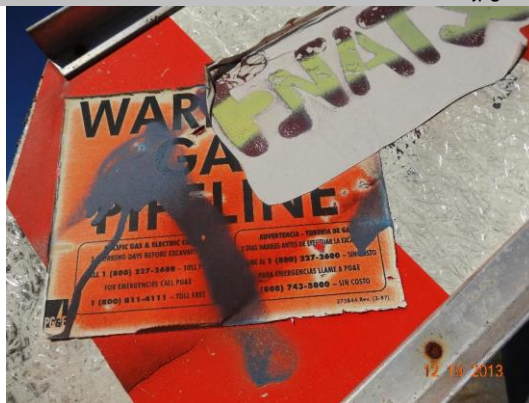
Photo 2 of 2 : UCIP_SP_2016_42131_52774.jpg

Marker visible on waterward slope.

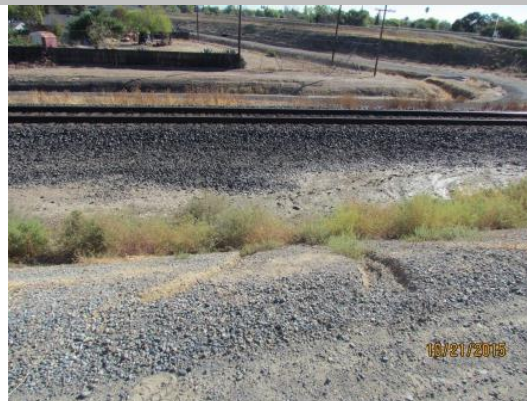
Photo 1 of 1 : SP_2016_NA0001_52_26_20160229_00005.jpg

LM Start	1.40	Rating **	M	Issue No.	26	
LM End	1.40	Issue Type +	Ma	Location *	LS	
Category	Earthen Levee			GPS Latitude/Longitude		
				Start		End
Item	Slope Stability			38.621054 °		38.621054 °
				-121.468008 °		-121.468008 °
DWR ID	DWR_NA0001_02_f_2015_26					
Comment Code						
S3 : Repair the levee slope damaged by vehicle traffic and prevent access where possible.						
Inspector Comment

View of the damaged landside levee slope.

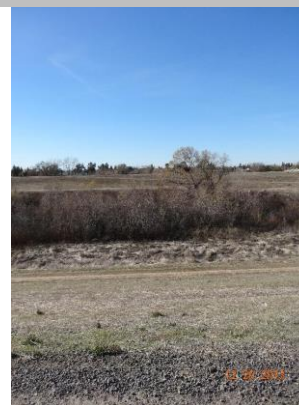
Photo 1 of 2 : UCIP_SP_2016_28667_52785.jpg

LM Start	1.96	Rating **	M	Issue No.	154
LM End	1.96	Issue Type +	En	Location *	LS
Category	Supplemental			GPS Latitude/Longitude	
				Start	End
Item	DWR UCIP Field Study			38.629129 °	38.629129 °
				-121.469556 °	-121.469556 °
DWR ID					
Comment Code					
Inspector Comment					
FS_ID:28667 DS_ID:24481 EP_NO: N/A Repair Type: Non-Urgent Crossing Status: Indicator Found UCIP Comments: Only found concrete box located on landward side toe. Need to contact owner to determine if crossing goes through levee and to notify that concrete box is filled with debris. FIELD_STRUCT_DESC: 12-inch CM railroad drainpipe through the levee at unknown depth. (USACE-1959). This entry matches the Drainage or Irrigation Structure referenced in O&M manual (Station 302+00). FS Date: 12/20/2013

View of waterward side.

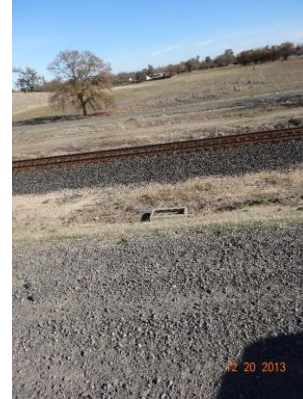
Photo 2 of 2 : UCIP_SP_2016_28667_52786.jpg

LM Start	1.96	Rating **	M	Issue No.	154 (cont)
LM End	1.96	Issue Type +	En	Location *	LS
Category	Supplemental			GPS Latitude/Longitude	
				Start	End
Item	DWR UCIP Field Study			38.629129 °	38.629129 °
				-121.469556 °	-121.469556 °
DWR ID					
Comment Code					
Inspector Comment					
FS_ID:28667 DS_ID:24481 EP_NO: N/A Repair Type: Non-Urgent Crossing Status: Indicator Found UCIP Comments: Only found concrete box located on landward side toe. Need to contact owner to determine if crossing goes through levee and to notify that concrete box is filled with debris. FIELD_STRUCT_DESC: 12-inch CM railroad drainpipe through the levee at unknown depth. (USACE-1959). This entry matches the Drainage or Irrigation Structure referenced in O&M manual (Station 302+00). FS Date: 12/20/2013

View of landward side. Depression visible at levee toe around concrete box.

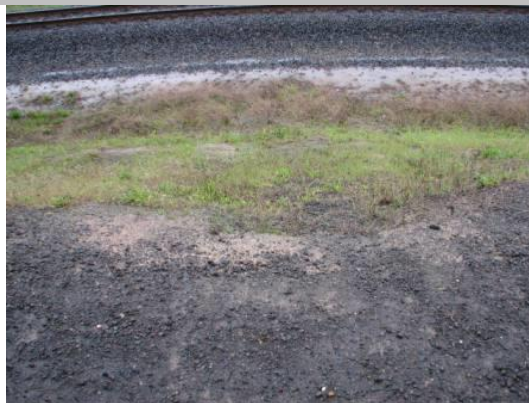
Photo 1 of 2 : SP_2016_NA0001_52_150_20160229_00007.jpg

LM Start	2.33	Rating **	A/W	Issue No.	150
LM End	2.33	Issue Type +	Ob	Location *	LS
Category	Earthen Levee			GPS Latitude/Longitude	
				Start	End
Item	Erosion / Bank Caving			38.634446 °	38.634446 °
				-121.470573 °	-121.470573 °
DWR ID	DWR_NA0001_02_s_2012_150				
Comment Code					
E1 : Note and monitor erosion site.					
Inspector Comment					
Monitor erosion at this location. Also noted in USACE PI.

03/14/2012 Photo shows depression, the issue has not gotten any worse since the fall 2011 inspection.

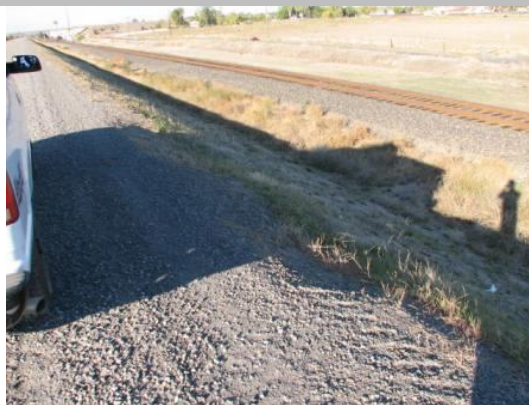
Photo 2 of 2 : SP_2016_NA0001_52_150_20160229_00008.jpg

11/16/2011 Depressions present on levee slope.

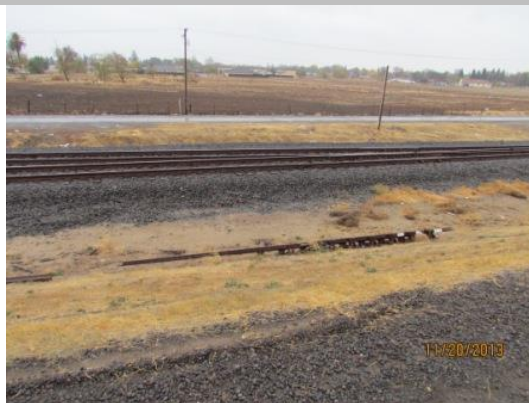
Photo 1 of 1 : SP_2016_NA0001_52_11_20160229_00003.jpg

LM Start	2.52	Rating **	M	Issue No.	11
LM End	2.52	Issue Type +	En	Location *	LS
Category	Earthen Levee			GPS Latitude/Longitude	
				Start	End
Item	Encroachments			38.637177 °	38.637177 °
				-121.471076 °	-121.471076 °
DWR ID	DWR_NA0001_02_f_2013_11				
Comment Code					
MA : Material					
Inspector Comment					
Railroad rails on landside levee slope.

View of the rails at the landside levee toe.

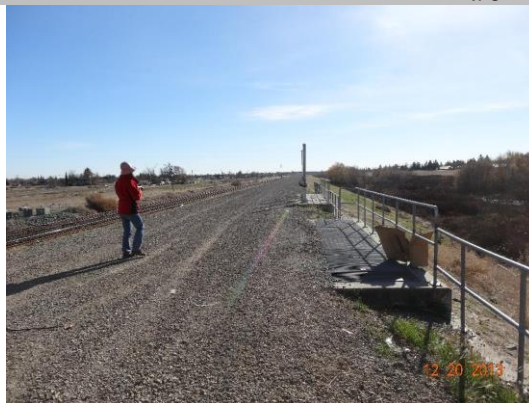
Photo 1 of 2 : UCIP_SP_2016_28724_52893.jpg

Comment Code					
Inspector Comment					
FS_ID:28724					
DS_ID:24608					
EP_NO: 9596					
Repair Type: Non-Urgent					
Crossing Status: Indicator Found					
UCIP Comments: Dense vegetation on waterward side limits inspector's inspection. Recommend removing vegetation.					
FIELD_STRUCT_DESC: [Magpie Creek Diversion Plant] 1 of 3: 54-inch steel drainpipe through the levee, 3.0 feet below the crown. Steel cutoff wall around pipe under center of levee. Siphon breaker in protective housing on waterside (WS) shoulder. Concrete headwall and flap gate on WS end. Trench on WS. Pumping plant on landside (LS). (Permit No. 9596-1975)					
FS Date: 12/20/2013

Overview of levee crown.

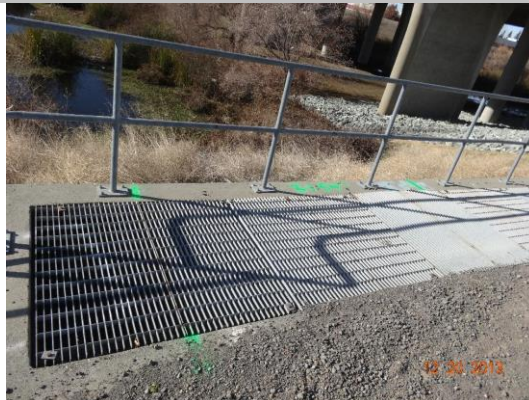
Photo 2 of 2 : UCIP_SP_2016_28724_52891.jpg

Concrete box contains 3-54 inch crossings.

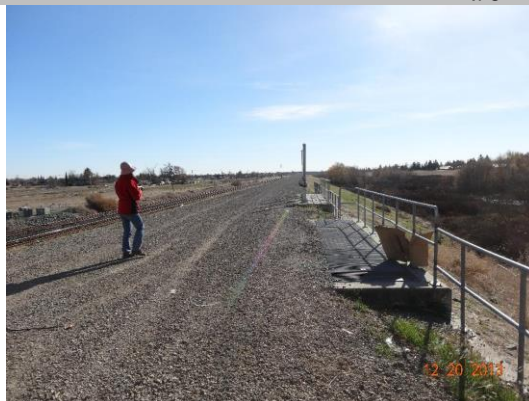
Photo 1 of 2 : UCIP_SP_2016_28726_52912.jpg

Comment Code					
Inspector Comment					
FS_ID:28726 DS_ID:24610 EP_NO: 9596 Repair Type: Urgent Crossing Status: Indicator Found UCIP Comments: Signs of pipe removal are visible on waterward and landward side--gate missing on WS and pump missing on LS. Need to contact owner to determine status of crossing. FIELD_STRUCT_DESC: [Magpie Creek Diversion Plant] 3 of 3: 54-inch steel drainpipe through the levee, 3.0 feet below the crown. Steel cutoff wall around pipe under center of levee. Siphon breaker in protective housing on waterside (WS) shoulder. Concrete headwall and flap gate on WS end. Trench on WS. Pumping plant on landside (LS). (Permit No. 9596-1975) FS Date: 12/20/2013

Overview of levee crown with two concrete boxes with multiple crossings inside.

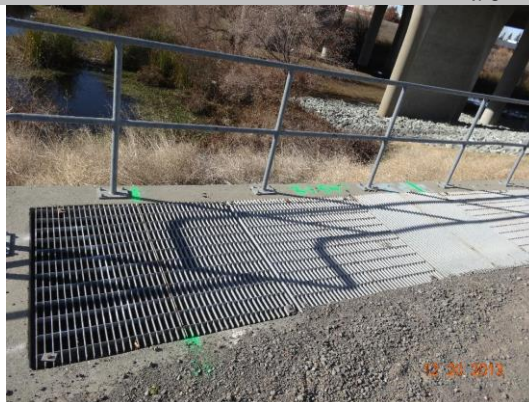
Photo 2 of 2 : UCIP_SP_2016_28726_52910.jpg

Concrete box contains 3-54 inch crossings.

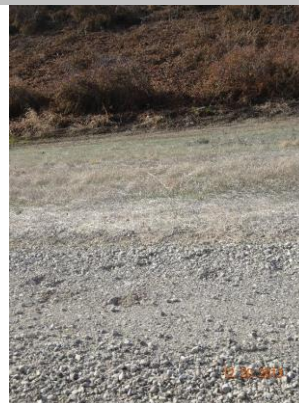
Photo 1 of 2 : UCIP_SP_2016_43049_55459.jpg

LM Start	2.87	Rating **	U	Issue No.	162
LM End	2.87	Issue Type +	En	Location *	LS
Category	Supplemental			GPS Latitude/Longitude	
				Start	End
Item	DWR UCIP Field Study			38.642162 °	38.642162 °
				-121.472041 °	-121.472041 °
DWR ID					
Comment Code					
Inspector Comment					
FS_ID:43049 DS_ID:24484 EP_NO: N/A Repair Type: Urgent Crossing Status: Indicator Found UCIP Comments: Hole visible just above the concrete box located on landward side--unable to determine if hole is associated with pipe failure or burrow activity. Need to contact owner to determine status and details of crossing's alignment. FIELD_STRUCT_DESC: 12-inch corrugated metal (CM) railroad drainpipe through the levee at unknown depth. (USACE-1959). This entry matches the Drainage or Irrigation Structure referenced in O&M manual (Station 340+00). FS Date: 12/20/2013

View of waterward side.

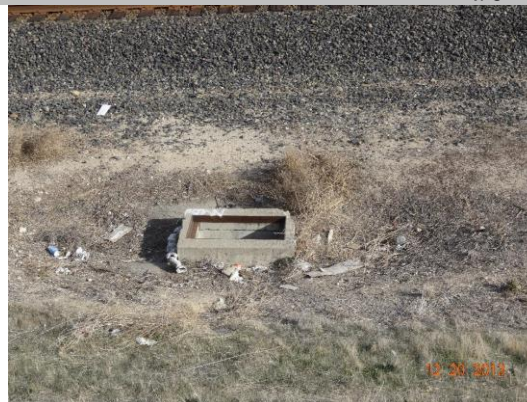
Photo 2 of 2 : UCIP_SP_2016_43049_55458.jpg

View of concrete box located on landward side.

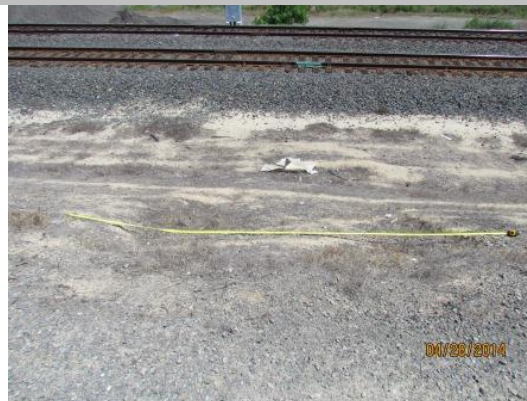
Photo 1 of 1 : SP_2016_NA0001_52_6_20160229_00002.jpg

LM Start	2.92	Rating **	A/W	Issue No.	6
LM End	2.92	Issue Type +	Ob	Location *	LS
Category	Earthen Levee			GPS Latitude/Longitude	
				Start	End
Item	Slope Stability			38.642950 °	38.642950 °
				-121.472166 °	-121.472166 °
DWR ID	DWR_NA0001_02_f_2012_6				
Comment Code					
S1 : Repair slope instability.					
Inspector Comment					
Monitor this location.

View of landside slope instability.

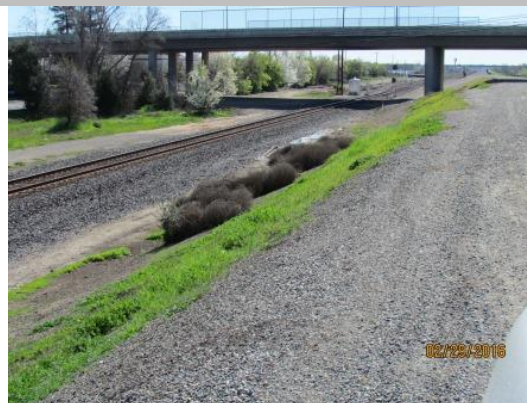
Photo 1 of 1 : SP_2016_NA0001_52_22_20160307_00048.jpg

LM Start	3.84	Rating **	M	Issue No.	22
LM End	3.84	Issue Type +	Ma	Location *	LS
Category	Earthen Levee			GPS Latitude/Longitude	
				Start	End
Item	Vegetation			38.656133 °	38.656133 °
				-121.474703 °	-121.474703 °
DWR ID	DWR_NA0001_02_s_2016_22				
Comment Code					
V2 : Remove the wild growth other than native grasses from the levee slopes.					
Inspector Comment					
Tumble weeds need to be removed.

View of the tumbleweeds at the landside levee toe.

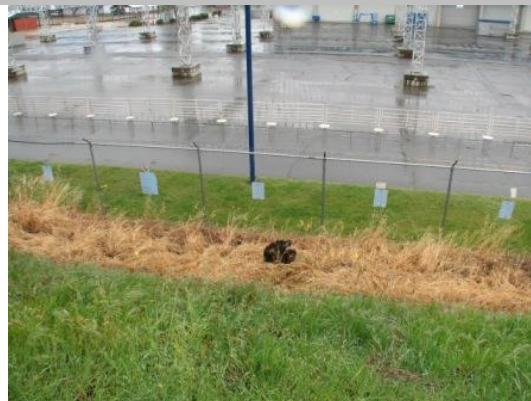
Photo 1 of 1 : SP_2016_NA0001_490_11_20160229_00003.jpg

LM Start	0.75	Rating **	U	Issue No.	11
LM End	0.75	Issue Type +	Ma	Location *	LS
Category	Earthen Levee			GPS Latitude/Longitude	
				Start	End
Item	Trim / Thin Trees			38.589359 °	38.589359 °
				-121.430990 °	-121.430990 °
DWR ID	DWR_NA0001_03_s_2012_11				
Comment Code					
T5 : Tree stumps.					
Inspector Comment					
Tree stump >2" Dia.

Tree stump on levee slope greater than 2" Dia.

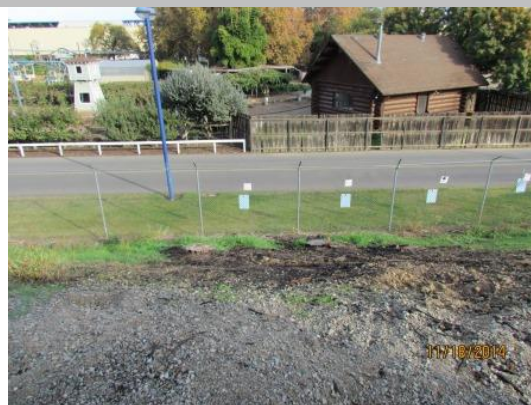
Photo 1 of 1 : SP_2016_NA0001_490_23_20160229_00004.jpg

LM Start	0.85	Rating **	N	Issue No.	23
LM End	0.85	Issue Type +	Ma	Location *	LS
Category	Earthen Levee			GPS Latitude/Longitude	
				Start	End
Item	Trim / Thin Trees			38.589624 °	38.589624 °
				-121.432935 °	-121.432935 °
DWR ID	DWR_NA0001_03_f_2014_23				
Comment Code					
T5 : Tree stumps.					
Inspector Comment

View of the tree stump on the landside levee slope.

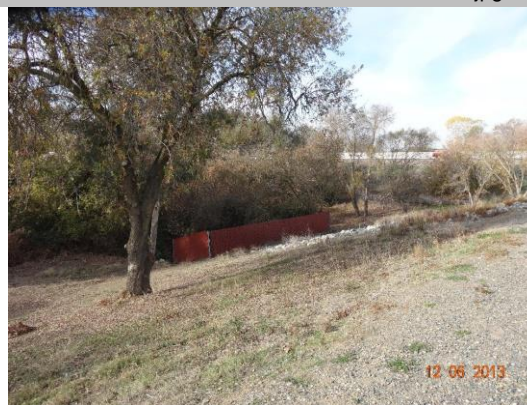
Photo 1 of 2 : UCIP_SP_2016_46983_53005.jpg

Comment Code					
Inspector Comment					
FS_ID:46983 DS_ID:24292 EP_NO: 5776 Repair Type: Urgent Crossing Status: Found UCIP Comments: Hole present next to concrete vault on levee crown (waterward side). Hole could be sink hole or burrow activity unable to determine. Need to contact owner to determine status of crossing and to investigate hole. FIELD_STRUCT_DESC: [Drainage Plant No. 2] 7 of 8: 18-inch steel drainpipe through the levee. Metal cutoff wall around pipe under landside (LS) shoulder. Siphon breakers in concrete box on the waterside (WS) shoulder. Pumping plant at LS toe. Access ramp to pumping plant. Concrete discharge box on the WS. Flap gate on the WS end. Outfall channel on WS. (Permit No. 5776-1972) FS Date: 12/3/2013

View of waterward side.

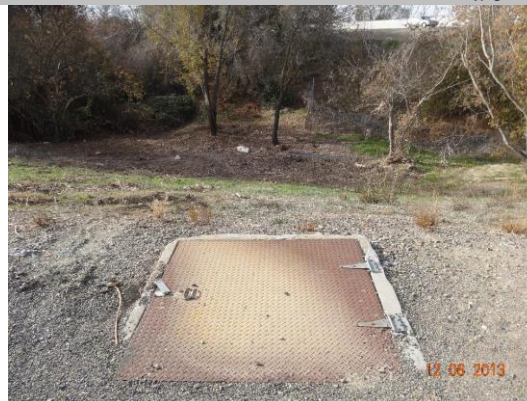
Photo 2 of 2 : UCIP_SP_2016_31223_57123.jpg

Comment Code						
Inspector Comment						
FS_ID:31223						
DS_ID:24643						
EP_NO: 2805						
Repair Type: Non-Urgent						
Crossing Status: Indicator Found						
UCIP Comments: Unable to confirm what crossings are going through levee. Will need to coordinate iwth owner to determine active crossings.						
FIELD_STRUCT_DESC: [Co Sanitation District No. 2 Pump Station]:						
24-inch reinforced concrete sewer main through the levee, 2.5 feet below the crown. Concrete cutoff wall around pipe under center of levee. Siphon breaker in housing at waterside (WS) shoulder.						
Treatment plant on landside (LS). (Permit No. 6216-1969) Line connects to an existing 18-inch sewer line and 8-inch line installed under permit no. 6216. The line also connects to an existing 24-inch line located on the LS. The 24-inch line on LS parallels the levee for approximately 54 feet and ends at the pump station.						
FS Date: 12/3/2013

Concrete box located on waterward shoulder.

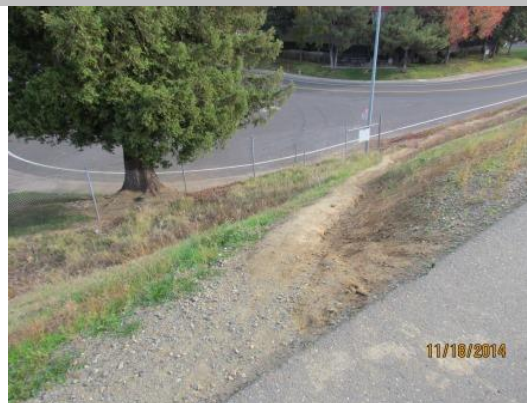
Photo 1 of 1 : SP_2016_NA0001_490_9_20160229_00002.jpg

LM Start	1.82	Rating **	A/W	Issue No.	9
LM End	1.82	Issue Type +	Ma	Location *	LS
Category	Earthen Levee			GPS Latitude/Longitude	
				Start	End
Item	Slope Stability			38.595700 °	38.595700 °
				-121.448198 °	-121.448198 °
DWR ID	DWR_NA0001_03_s_2012_9				
Comment Code					
S2 : Repair the levee slope damaged by foot traffic and prevent access where possible.					
Inspector Comment					
Slope repaired. Monitor for possible future erosion.

View of the erosion on landside levee slope due to pedestrian traffic.

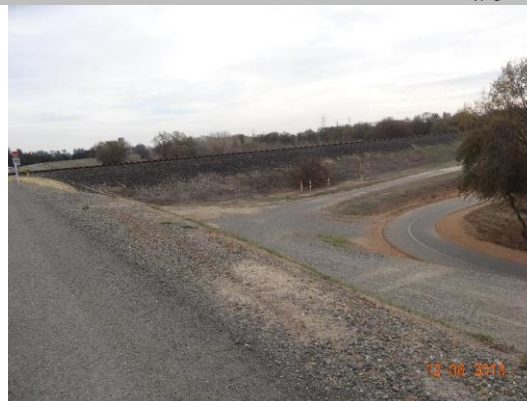
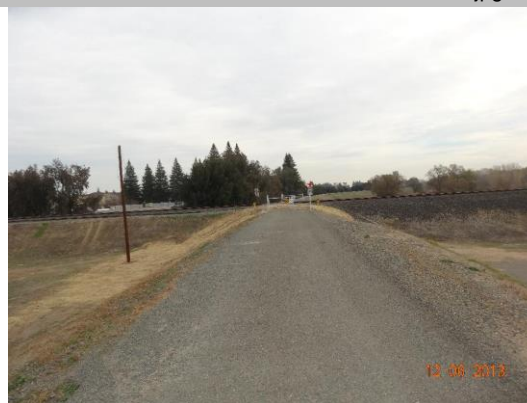
LM Start	1.91	Rating **	M	Issue No.	39
LM End	1.91	Issue Type +	En	Location *	LS
Category	Supplemental			GPS Latitude/Longitude	
				Start	End
Item	DWR UCIP Field Study			38.596096 °	38.596096 °
				-121.449815 °	-121.449815 °
DWR ID					
Comment Code					
Inspector Comment					
FS_ID:31230					
DS_ID:24801					
EP_NO: N/A					
Repair Type: Non-Urgent					
Crossing Status: Found					
UCIP Comments: No permit found--need to contact owner to determine status of crossing.					
FIELD_STRUCT_DESC: Gas line through levee at unknown depth.					
Markers visible on waterside (WS) and landside (LS). Kinder Morgan contact's information is 916-363-1666.					
FS Date: 12/6/2013

View of waterward side.

Overview of levee crown at crossing.

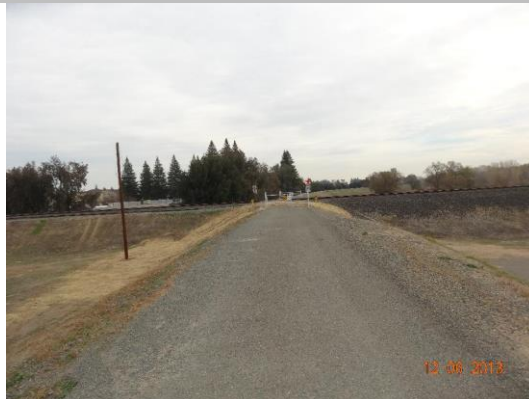
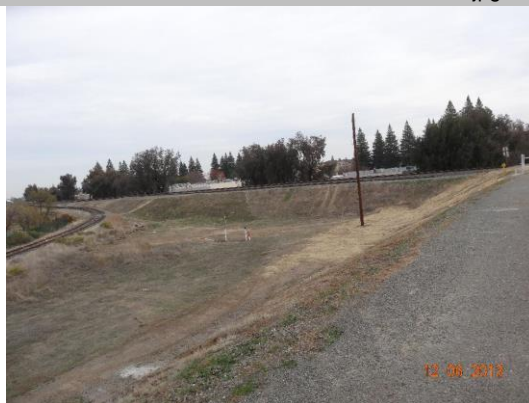
LM Start	1.91	Rating **	M	Issue No.	33
LM End	1.91	Issue Type +	En	Location *	LS
Category	Supplemental			GPS Latitude/Longitude	
				Start	End
Item	DWR UCIP Field Study			38.596108 °	38.596108 °
				-121.449887 °	-121.449887 °
DWR ID					
Comment Code					
Inspector Comment					
FS_ID:29826					
DS_ID:24294					
EP_NO: N/A					
Repair Type: Non-Urgent					
Crossing Status: Indicator Found					
UCIP Comments: Unable to confirm the diameter size or which owner is responsible for crossing. Owner could be Quest Communication or MCI--Need to contact owner to confirm crossing and obtain encroachment permit for work.					
FIELD_STRUCT_DESC: Communications conduit through the levee at unknown depth.					
FS Date: 12/6/2013

Overview of levee crown looking upstram at crossing.

View of landward side--conduit markers visible.

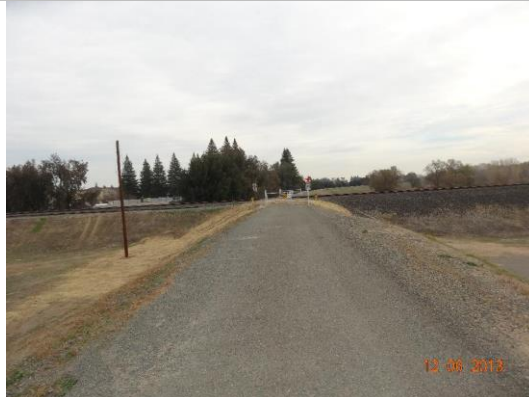
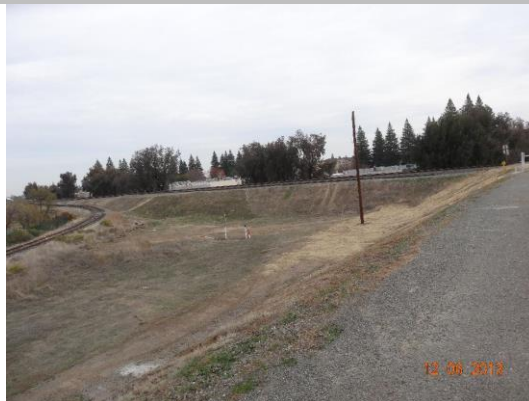
LM Start	1.92	Rating **	M	Issue No.	34
LM End	1.92	Issue Type +	En	Location *	LS
Category	Supplemental			GPS Latitude/Longitude	
				Start	End
Item	DWR UCIP Field Study			38.596108 °	38.596108 °
				-121.449887 °	-121.449887 °
DWR ID					
Comment Code					
Inspector Comment					
FS_ID:29827					
DS_ID:24296					
EP_NO: N/A					
Repair Type: Non-Urgent					
Crossing Status: Indicator Found					
UCIP Comments: Unable to confirm the diameter size or which owner is responsible for crossing. Owner could be Quest Communication or MCI--Need to contact owner to confirm crossing and obtain encroachment permit for work.					
FIELD_STRUCT_DESC: 3-inch cable through the levee, 2.5 feet below the crown. Two overhead telephone lines across the levee at location.					
FS Date: 12/6/2013

Overview of levee crown looking upstream at crossing.

Conduit markers visible on landward side.

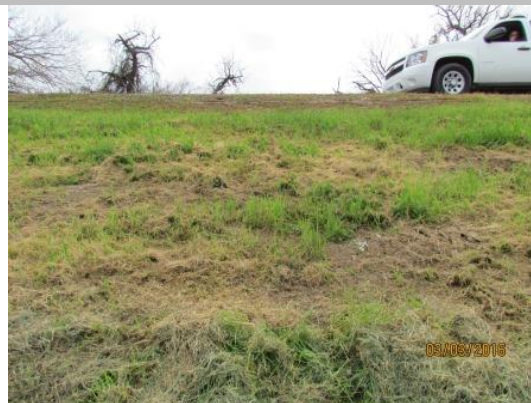
Photo 1 of 1 : SP_2016_NA0001_490_25_20160308_00034.jpg

LM Start	2.40	Rating **	A/W	Issue No.	25
LM End	2.40	Issue Type +	Ma	Location *	LS
Category	Earthen Levee			GPS Latitude/Longitude	
				Start	End
Item	Animal Control			38.595549 °	38.595549 °
				-121.458714 °	-121.458714 °
DWR ID	DWR_NA0001_03_f_2015_25				
Comment Code					
A1 : Exterminate rodents and backfill and compact or grout burrows.					
Inspector Comment					
The holes were backfilled by the LMA.

View of the backfilled rodent holes on the landside levee slope.

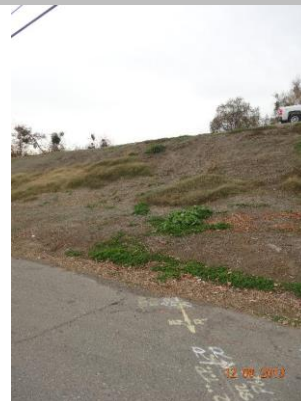
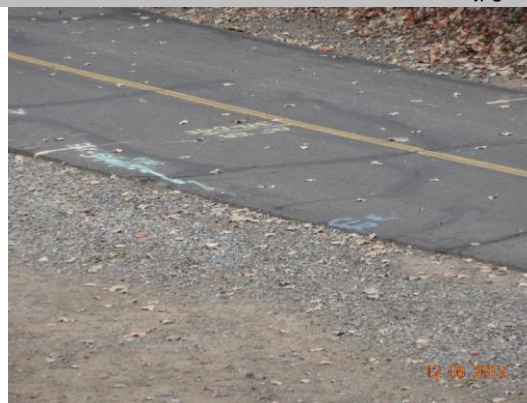
LM Start	3.29	Rating **	U	Issue No.	32
LM End	3.29	Issue Type +	En	Location *	LS
Category	Supplemental			GPS Latitude/Longitude	
				Start	End
Item	DWR UCIP Field Study			38.600718 °	38.600718 °
				-121.471491 °	-121.471491 °
DWR ID					
Comment Code					
Inspector Comment					
FS_ID:43284 DS_ID:24648 EP_NO: 911 Repair Type: Urgent Crossing Status: Found UCIP Comments: 2/6/2015 Permit information was entered and crossing description updated. (UCIP-Olivia)12/3/13 Need to contact owner to determine status of crossing. Markers missing. (UCIP-Olivia) FIELD_STRUCT_DESC: 12-3/4-inch gas line through the levee. FS Date: 12/3/2013

View of waterward side slope and USA paint markings indicating alignment.

Underground service alert (USA) marked approximate alignment for 12-inch gas line through levee.

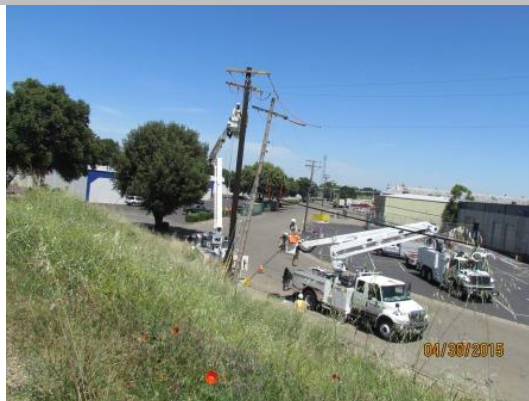
Photo 1 of 1 : SP_2016_NA0001_490_24_20160229_00005.jpg

LM Start	3.31	Rating **	M	Issue No.	24
LM End	3.31	Issue Type +	En	Location *	LS
Category	Earthen Levee			GPS Latitude/Longitude	
				Start	End
Item	Encroachments			38.600958 °	38.600958 °
				-121.471618 °	-121.471618 °
DWR ID	DWR_NA0001_03_s_2015_24				
Comment Code					
PO : Pole					
Inspector Comment					
SMUD replacing old pole at the landside toe of the levee. May or may not be permitted.

View of a new pole installed at the landside levee toe.

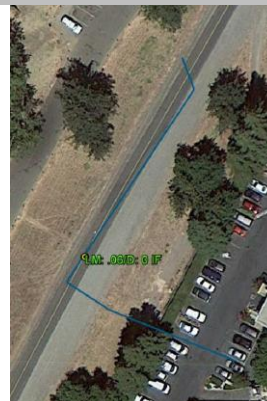
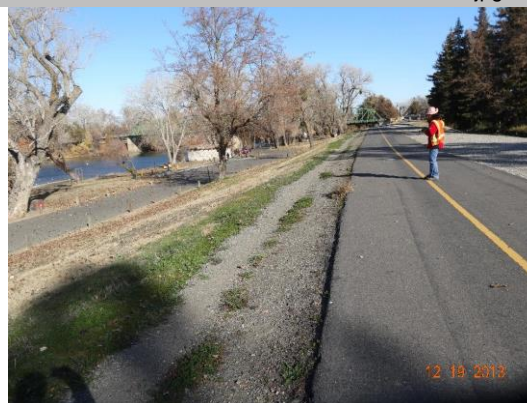
FS_ID:29003
DS_ID:24344
EP_NO: N/A
Repair Type: Non-Urgent
Crossing Status: Indicator Found
UCIP Comments: Metal boxes located on landward side could be associated with utility -- unable to confirm. Will need to contact owner.
FIELD_STRUCT_DESC: Electrical conduit through the levee at unknown depth.
FS Date: 12/19/2013

Approximate alignment provided by the City of Sacramento for 2 inch line. Point labelled in green is field verified location where signs of crossing exist.

Overview of levee crown and waterward side.

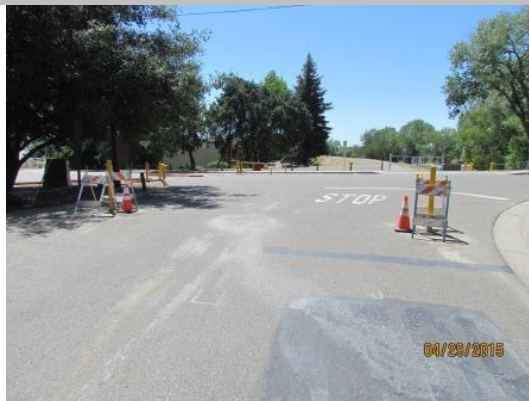
Photo 1 of 1 : SP_2016_NA0001_55_242_20160229_00187.jpg

LM Start	0.20	Rating **	M	Issue No.	242
LM End	0.20	Issue Type +	En	Location *	CR
Category	Earthen Levee			GPS Latitude/Longitude	
				Start	End
Item	Encroachments			38.598832 °	38.598832 °
				-121.504984 °	-121.504984 °
DWR ID	DWR_NA0001_04_s_2015_242				
Comment Code					
FE : Fence					
Inspector Comment					
Unpermitted gate being installed by Sacramento County Parks.

View of the gate installation in progress on the levee crown.

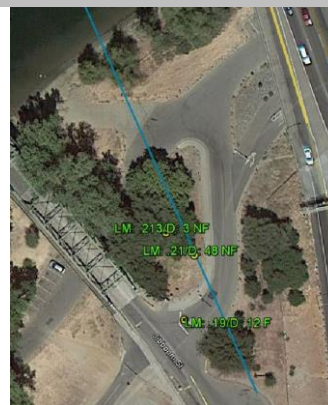
Photo 1 of 1 : UCIP_SP_2016_29006_53414.jpg

LM Start	0.21	Rating **	M	Issue No.	760
LM End	0.21	Issue Type +	En	Location *	CR
Category	Supplemental			GPS Latitude/Longitude	
				Start	End
Item	DWR UCIP Field Study			38.598982 °	38.598982 °
				-121.505045 °	-121.505045 °
DWR ID					
Comment Code					
Inspector Comment					
FS_ID:29006 DS_ID:24435 EP_NO: 17171 Repair Type: Non-Urgent Crossing Status: Not Found UCIP Comments: Unable to find any indications that crossing is still active. Will need to contact owner to determine status of crossing. FIELD_STRUCT_DESC: 48-inch steel water line through the levee, approximately 32.0 feet below the crown. Siphon and blowoff valves in concrete riser on the landside (LS). (Permit No. 17171-2001) FS Date: 12/19/2013

Approximate alignment provided by the City of Sacramento--crossing not found during field visit.

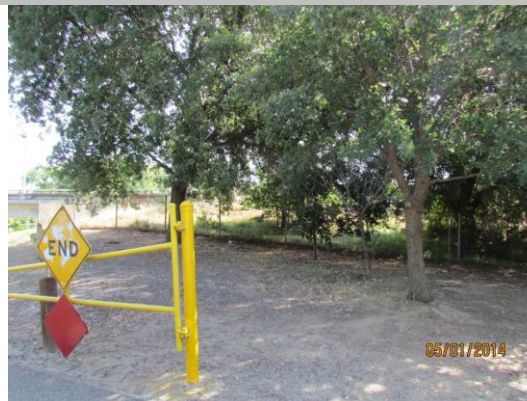
Photo 1 of 1 : SP_2016_NA0001_55_177_20160229_00154.jpg

LM Start	0.21	Rating **	M	Issue No.	177
LM End	0.21	Issue Type +	En	Location *	CR
Category	Earthen Levee			GPS Latitude/Longitude	
				Start	End
Item	Vegetation			38.598980 °	38.598980 °
				-121.504773 °	-121.504773 °
DWR ID	DWR_NA0001_04_s _ 2012_177				
Comment Code					
V6 : Landscaping					
Inspector Comment					
Landscaping on levee crown at overpass.

View of the landscaping on the levee crown.

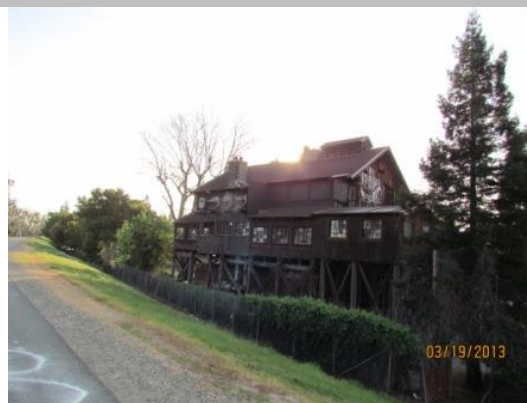
Photo 1 of 1 : SP_2016_NA0001_55_1_20160229_00001.jpg

LM Start	0.31	Rating **	M	Issue No.	1
LM End	0.45	Issue Type +	En	Location *	LS
Category	Earthen Levee			GPS Latitude/Longitude	
				Start	End
Item	Vegetation			38.599835 °	38.600769 °
				-121.503448 °	-121.501133 °
DWR ID	DWR_NA0001_04_s _ 2012_1				
Comment Code					
V6 : Landscaping					
Inspector Comment					
Vines and privacy fence within 10-ft of the landside toe or on the levee slope obstruct visibility and access.

View of the vines obstructing visibility.

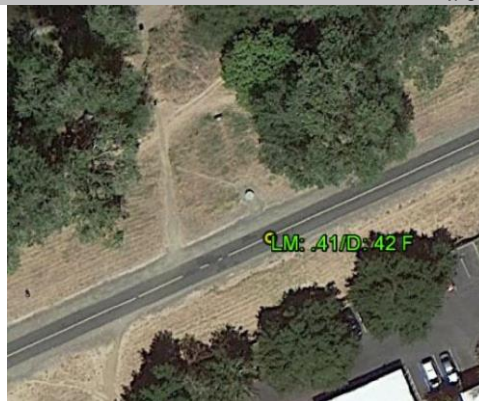
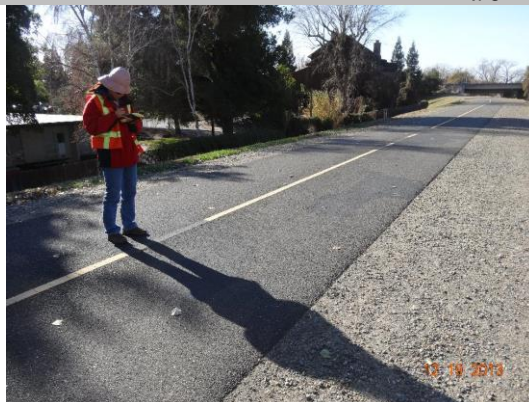
Comment Code					
Inspector Comment					
FS_ID:31249					
DS_ID:24303					
EP_NO: N/A					
Repair Type: Non-Urgent					
Crossing Status: Found					
UCIP Comments: Non-functional crossing--need additional information about how crossing was abandoned.					
FIELD_STRUCT_DESC: Abandoned 42-inch corrugated metal (CM) pipe through the levee, 16.5 feet below the crown. Gravel filled with both ends welded shut. Flap gate on the waterside (WS) end. Slide gate in CM riser and splash board drain structure on the landside (LS). (USACE-1955). This entry matches the Drainage or Irrigation Structure referenced in O&M manual (Station 10+00).					
FS Date: 12/19/2013

Overview of crossing location.

View of levee crown at this location.

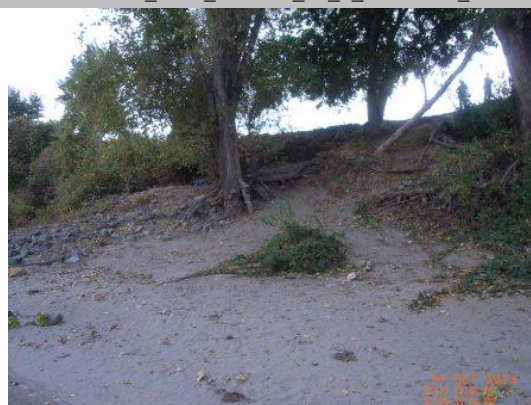
Photo 1 of 1 : SP_2016_NA0001_55_7_20160229_00008.jpg

LM Start	1.61	Rating **	M	Issue No.	7
LM End	1.65	Issue Type +	Ma	Location *	WS
Category	Supplemental			GPS Latitude/Longitude	
				Start	End
Item	2015 USACE Erosion Survey, DRAFT			38.599095 °	38.598791 °
				-121.480337 °	-121.479799 °
DWR ID	DWR_NA0001_04_s_2016_7				
Comment Code					
Inspector Comment					
2012 - Located just downstream of older repair. Failing rock at the upstream end. Erosion of the bank has exposed large tree roots. 2015: No observed changes. [2015 Site ID: LAR_1-8_L]

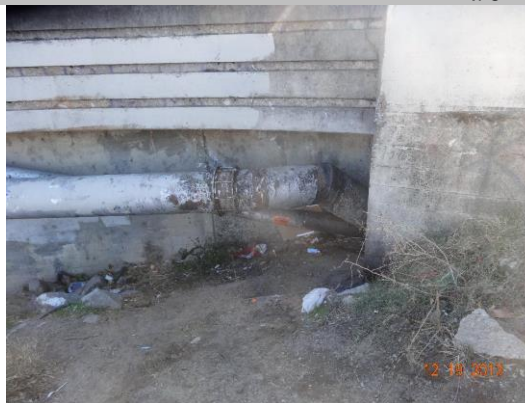
Photo 2 of 2 : UCIP_SP_2016_29027_53495.jpg

LM Start	1.88	Rating **	U	Issue No.	756 (cont)	
LM End	1.88	Issue Type +	En	Location *	WS	
Category	Supplemental			GPS Latitude/Longitude		
				Start		End
Item	DWR UCIP Field Study			38.595911 °	38.595911 °	
				-121.477485 °	-121.477485 °	
DWR ID						
Comment Code						
Inspector Comment						
FS_ID:29027						
DS_ID:24307						
EP_NO: N/A						
Repair Type: Urgent						
Crossing Status: Found						
UCIP Comments: No markers or labels visible to indicate line is gas line--unable to confirm.						
FIELD_STRUCT_DESC: 1 of 2: 20-inch gas main through the levee, 5.0 feet below the crown.						
FS Date: 12/19/2013

Two crossings visible at bridge.

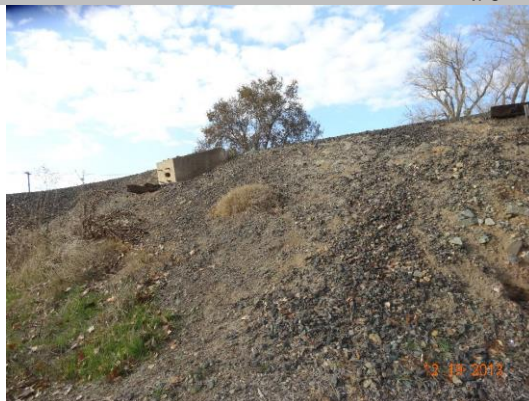
Photo 1 of 2 : UCIP_SP_2016_29927_55259.jpg

LM Start	2.25	Rating **	M	Issue No.	753
LM End	2.25	Issue Type +	En	Location *	LS
Category	Supplemental			GPS Latitude/Longitude	
				Start	End
Item	DWR UCIP Field Study			38.591923 °	38.591923 °
				-121.473744 °	-121.473744 °
DWR ID					
Comment Code					
Inspector Comment					
FS_ID:29927					
DS_ID:24310					
EP_NO: 14150					
Repair Type: Non-Urgent					
Crossing Status: Indicator Found					
UCIP Comments: unable to confirm if crossing is 4-inch steel conduit--will need to coordinate with owner.					
FIELD_STRUCT_DESC: 4-inch steel pipe conduit containing fiber optic cables through the levee, 3.5 feet below the crown. Markers on the levee shoulder. Rock revetment on the waterside (WS) slope. (Permit No. 14150-1986)					
FS Date: 12/19/2013

View of waterward slope--concrete box could be associated with conduit?

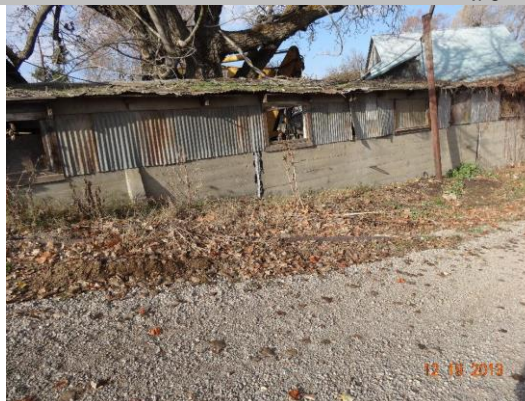
Photo 2 of 2 : UCIP_SP_2016_29944_55266.jpg

Item	DWR UCIP Field Study			38.587906	°	38.587906
				-121.466689	°	-121.466689
DWR ID						
Comment Code						
Inspector Comment						
FS_ID:29944 DS_ID:24327 EP_NO: 3362 Repair Type: Non-Urgent Crossing Status: Found UCIP Comments: Pipe sections abandoned on levee crown--need to contact owner to determine status of crossing. FIELD_STRUCT_DESC: 12-inch steel pipe through the levee. Pipe extends from a settling pond, on the left bank berm, to an existing borrow pit located in the overflow area adjacent to the right bank. The pipeline is buried through the top of the riverbanks and buried in the left bank with aggregate revetment placed on the bank. The remainder of the pipeline is exposed across the bottom of the channel and the right bank. The line is used to divert wash water return from the gravel plant to the opposite side of the river. (Permit 8146-1974) FS Date: 12/19/2013

View of structure located on levee crown.

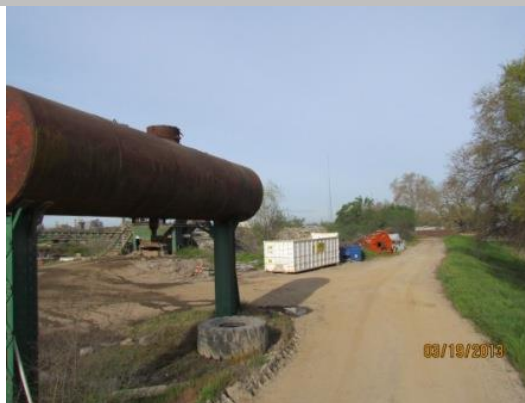
Photo 1 of 1 : SP_2016_NA0001_55_3_20160229_00003.jpg

LM Start	2.72	Rating **	M	Issue No.	3
LM End	2.86	Issue Type +	En	Location *	LS
Category	Earthen Levee			GPS Latitude/Longitude	
				Start	End
Item	Encroachments			38.587939 °	38.587299 °
				-121.466635 °	-121.464320 °
DWR ID	DWR_NA0001_04_s_2012_3				
Comment Code					
EQ : Equipment					
Inspector Comment					
Bell Marine, LMA sent a letter to property owner for the violation.

View of the debris obstructing visibility and access.

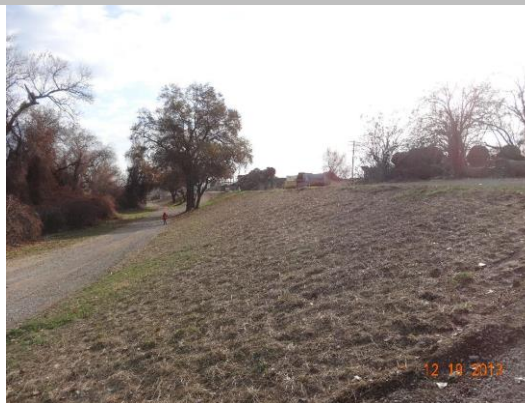
Photo 1 of 2 : UCIP_SP_2016_31444_57486.jpg

LM Start	2.77	Rating **	M	Issue No.	761
LM End	2.77	Issue Type +	En	Location *	CR
Category	Supplemental			GPS Latitude/Longitude	
				Start	End
Item	DWR UCIP Field Study			38.587629 °	38.587629 °
				-121.465905 °	-121.465905 °
DWR ID					
Comment Code					
Inspector Comment					
FS_ID:31444 DS_ID:24805 EP_NO: N/A Repair Type: Non-Urgent Crossing Status: Indicator Found UCIP Comments: No permit (unauthorized crossing)--need additional information about crossing. FIELD_STRUCT_DESC: Standpipe located on waterward shoulder. Unable to confirm pipe alignment. No permit found. FS Date: 12/19/2013

View of waterward slope.

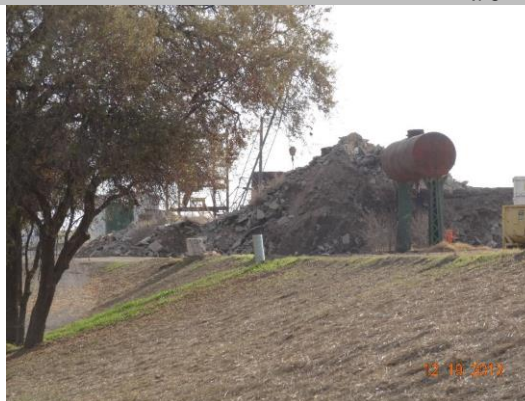
Photo 2 of 2 : UCIP_SP_2016_31444_57485.jpg

LM Start	2.77	Rating **	M	Issue No.	761 (cont)
LM End	2.77	Issue Type +	En	Location *	CR
Category	Supplemental			GPS Latitude/Longitude	
				Start	End
Item	DWR UCIP Field Study			38.587629 °	38.587629 °
				-121.465905 °	-121.465905 °
DWR ID					
Comment Code					
Inspector Comment					
FS_ID:31444 DS_ID:24805 EP_NO: N/A Repair Type: Non-Urgent Crossing Status: Indicator Found UCIP Comments: No permit (unauthorized crossing)--need additional information about crossing. FIELD_STRUCT_DESC: Standpipe located on waterward shoulder. Unable to confirm pipe alignment. No permit found. FS Date: 12/19/2013

Standpipe located on waterward shoulder.

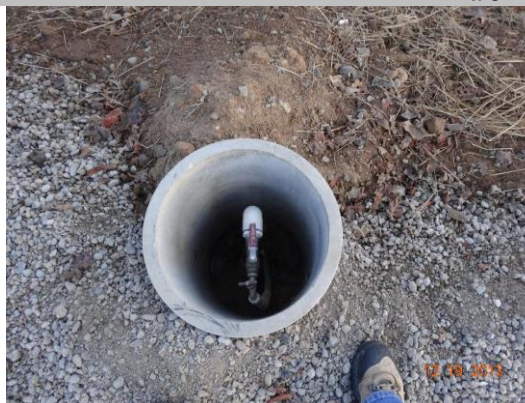
Photo 1 of 1 : UCIP_SP_2016_31445_57487.jpg

LM Start	2.82	Rating **	M	Issue No.	762
LM End	2.82	Issue Type +	En	Location *	CR
Category	Supplemental			GPS Latitude/Longitude	
				Start	End
Item	DWR UCIP Field Study			38.587438 °	38.587438 °
				-121.464989 °	-121.464989 °
DWR ID					
Comment Code					
Inspector Comment					
FS_ID:31445 DS_ID:24806 EP_NO: N/A Repair Type: Non-Urgent Crossing Status: Found UCIP Comments: No permit found (unauthorized?)--need additional information about crossing. FIELD_STRUCT_DESC: Standpipe located on waterside (WS) shoulder. Pipe crosses levee crown and landside (LS). Pipe used for irrigation. No Permit found. FS Date: 12/13/2013

Spigot located inside riser located on waterward shoulder.

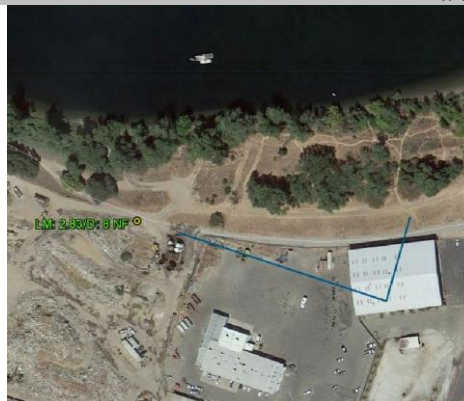
Photo 1 of 1 : UCIP_SP_2016_31253_57216.jpg

Comment Code					
Inspector Comment					
FS_ID:31253 DS_ID:24328 EP_NO: 5890 Repair Type: Non-Urgent Crossing Status: Not Found UCIP Comments: Need to contact owner to determine status of crossing--approximate alignment indicates pipe does not cross levee however records shows drain pipe crosses levee. FIELD_STRUCT_DESC: 8-inch corrugated metal (CM) drainpipe through the levee, 2.1 feet below the crown. Concrete drop inlet structure at waterside (WS) shoulder. Maintenance facilities and yard on the landside (LS). Rock revetment on WS slope. (Pemit No. 5890-1968) This entry matches the Drainage or Irrigation Structure referenced in O&M manual (Station 156+75). FS Date: 12/19/2013

Approximate alignment indicated in blue and approximate location indicated by DWR-UCIP in green label.

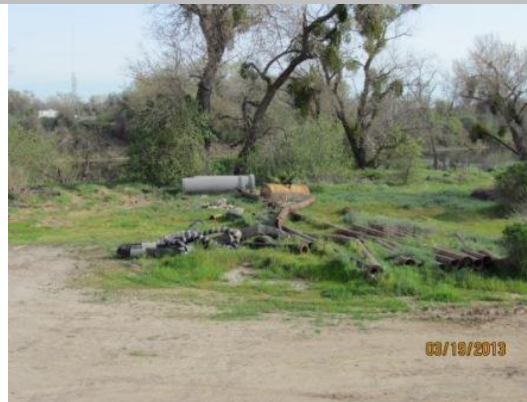
Photo 1 of 2 : SP_2016_NA0001_55_4_20160229_00004.jpg

LM Start	2.83	Rating **	M	Issue No.	4
LM End	2.83	Issue Type +	En	Location *	WS
Category	Earthen Levee			GPS Latitude/Longitude	
				Start	End
Item	Encroachments			38.587272 °	38.587272 °
				-121.464768 °	-121.464768 °
DWR ID	DWR_NA0001_04_s_2012_4				
Comment Code					
DE : Debris					
Inspector Comment					
Bell Marine, LMA sent a letter to the property owner for this violation.

View of the debris stored in floodway.

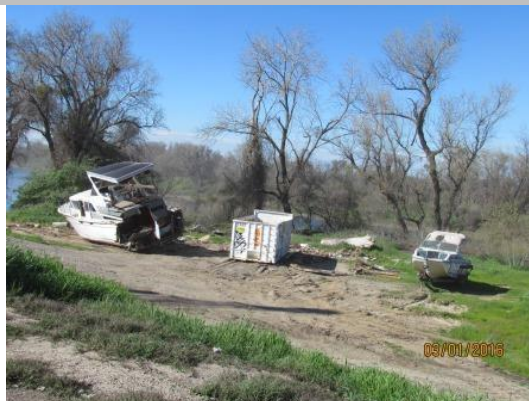
Photo 2 of 2 : SP_2016_NA0001_55_4_20160307_00243.jpg

LM Start	2.83	Rating **	M	Issue No.	4 (cont)	
LM End	2.83	Issue Type +	En	Location *	WS	
Category	Earthen Levee			GPS Latitude/Longitude		
				Start		End
Item	Encroachments			38.587272 °		38.587272 °
				-121.464768 °		-121.464768 °
DWR ID	DWR_NA0001_04_s_2012_4					
Comment Code						
DE : Debris						
Inspector Comment						
Bell Marine, LMA sent a letter to the property owner for this violation.

View of the derelict boats in the floodway. Bell Marine has a service contract to dispose of abandoned boats for the City.

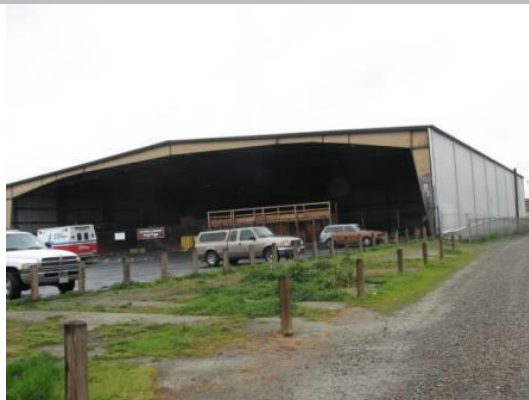
Photo 1 of 1 : SP_2016_NA0001_55_5_20160229_00006.jpg

LM Start	2.92	Rating **	U	Issue No.	5
LM End	2.96	Issue Type +	En	Location *	LS
Category	Earthen Levee			GPS Latitude/Longitude	
				Start	End
Item	Encroachments			38.587251 °	38.587318 °
				-121.463237 °	-121.462513 °
DWR ID	DWR_NA0001_04_s_2012_5				
Comment Code					
BU : Building					
Inspector Comment					
City of Sacramento building. Building is now Sutter's Landing Skate Park.

03/16/2012 Sutter's Landing Skate Park.

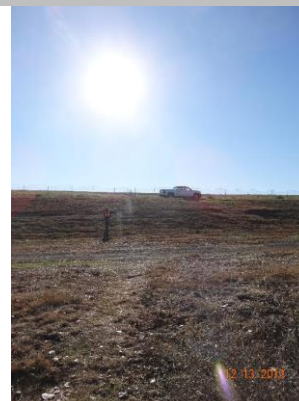
Photo 1 of 2 : UCIP_SP_2016_31254_57217.jpg

Comment Code					
Inspector Comment					
FS_ID:31254 DS_ID:24330 EP_NO: 15041 Repair Type: Non-Urgent Crossing Status: Indicator Found UCIP Comments: Hole present on riser located on landward side--contact owner. Additional pipe found in waterward berm. Unable to confirm if this pipe section is part of crossing--size does not match. Unable to find CM standpipe on waterward side. FIELD_STRUCT_DESC: 16-inch corrugated metal (CM) drainpipe through the levee. Steel cutoff wall around pipe at center of levee. Storm drain gate on landside (LS) shoulder. Drainage ditch on LS. CM standpipe on WS. Rock-filled ditch on WS. (Permit No. 15041-1993) FS Date: 12/13/2013

Overview of waterward side.

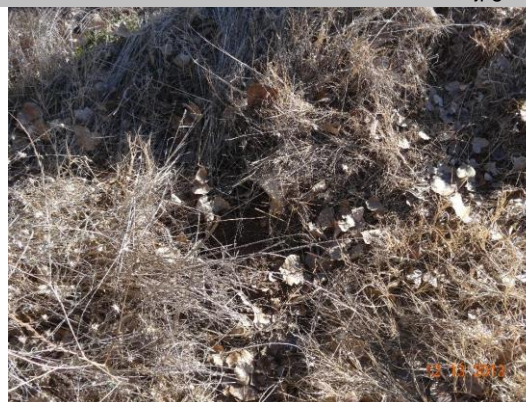
Photo 2 of 2 : UCIP_SP_2016_31254_57219.jpg

Pipe buried by vegetation--unable to determine if pipe goes through levee.

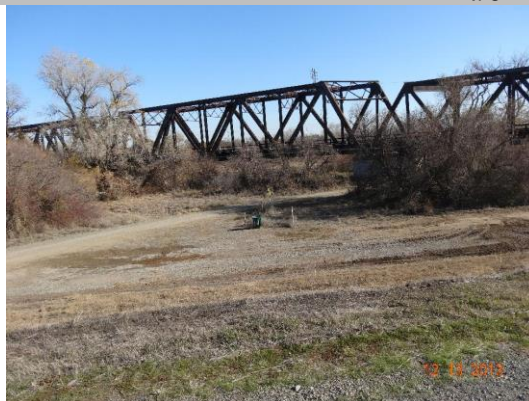
Photo 1 of 2 : UCIP_SP_2016_42128_56573.jpg

Comment Code					
Inspector Comment					
FS_ID:42128 DS_ID:24807 EP_NO: N/A Repair Type: Non-Urgent Crossing Status: Indicator Found UCIP Comments: 11/3/2014 (DWR-Olivia) Need to contact owner to determine status of crossing. Priority under Part IX has been changed from Urgent to Non-Urgent as a measure to normalize the data. Per Title 23 markers are necessary for pressure line--markers present. Recommend LMA to contact owner to determine additional information details--CVFPB permit, depth of pipe through levee, alignment, and last inspection completed confirming integrity of crossing.No permit found. Will need to contact owner to determine the status of crossing. FIELD_STRUCT_DESC: Petroleum pipeline through the levee, unknow depth. Markers visible on waterside (WS). Unable to confirm alignment. Kinder Morgan (Owner) contact information is 916-363-1666. FS Date: 12/13/2013

View of waterward side.
